**ALLEGANY COUNTY FIRE SERVICE
FIRE INVESTIGATION FORM (short)**

INCIDENT #: FI 20-003	FI'S RESPONDING: 4 Edwards, 5 Aderhold, 12 Valeri, 51 Luckey
-----------------------	--------------------------------------------------------------

TYPE OF INCIDENT: Residential Fire

INCIDENT ADDRESS: 192 Bells Brook RD

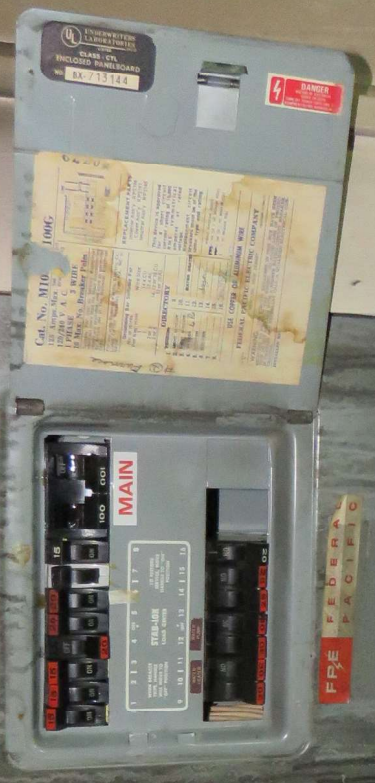
UL UNDERWRITERS LABORATORIES
CLASS: CUL
ENCLOSED PANELBOARD
BX-713144

100C
Cat. No. M10
125/250V AC
1 PHASE
16 Max. No. Breakers
